# TEST REPORT

**Test specification** .....: IEC 61215-2:2021 UV test

**Test item description** .....: Photovoltaic (PV) module(s)

**Model/Type reference** .....: PRD670-132MT (Test sample)

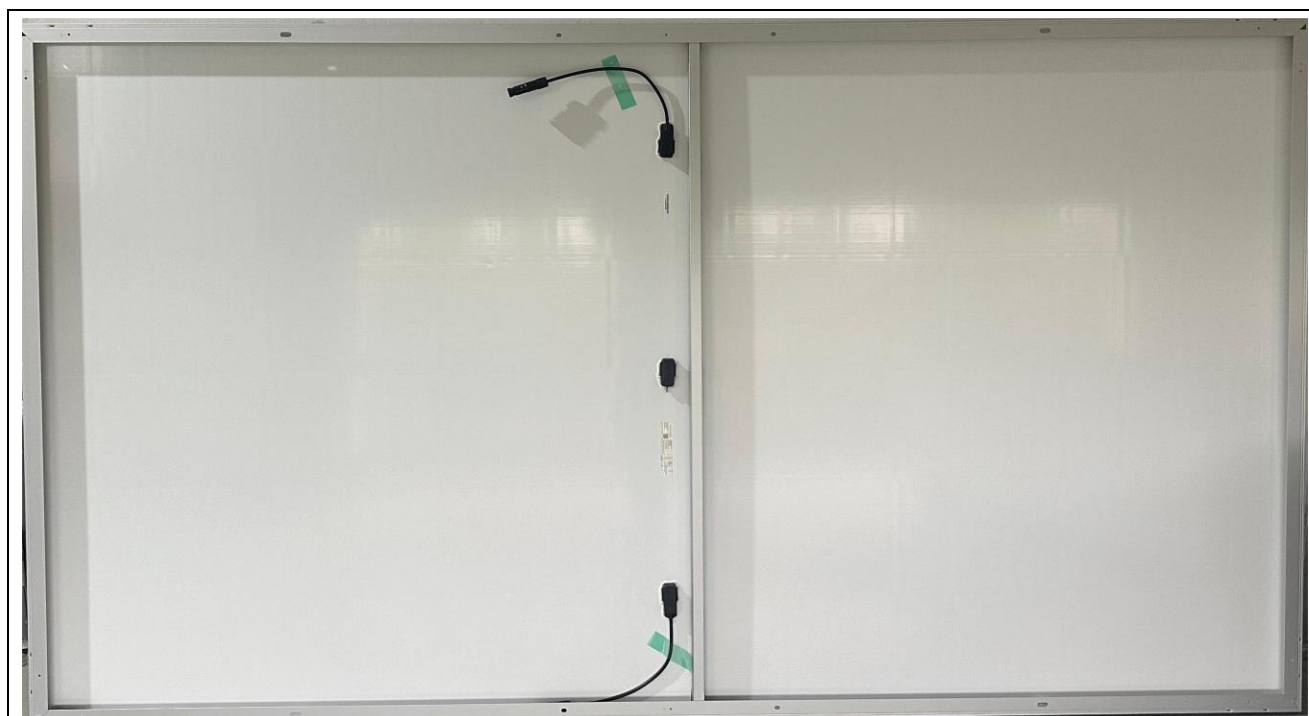
Rear view of sample

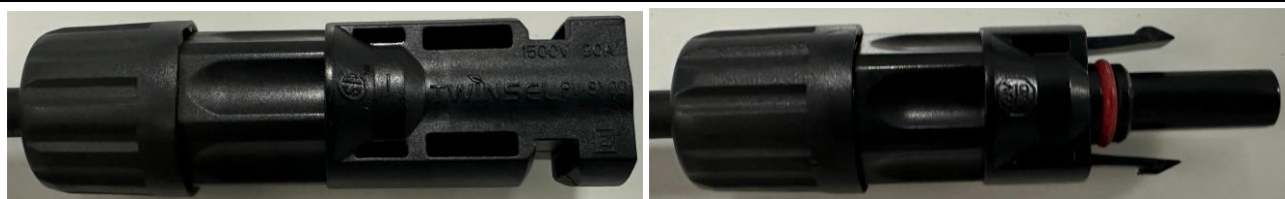
View of connector

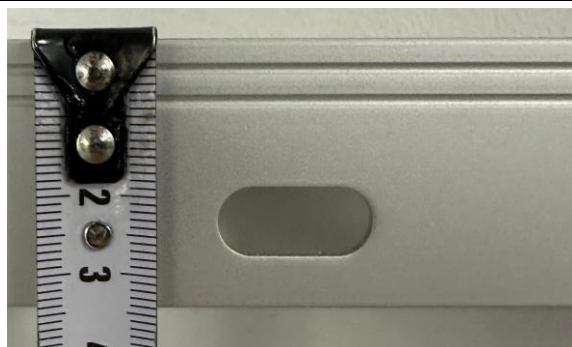
View of mounting holes

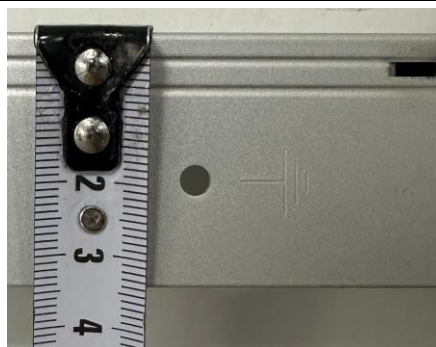
View of ground

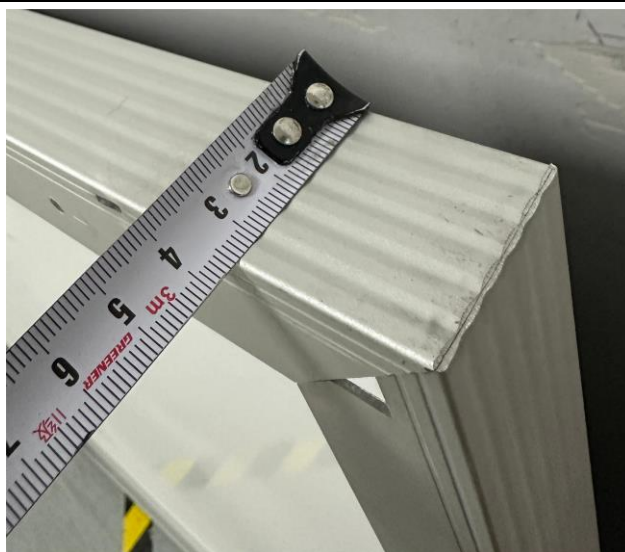
View of frame
